STRUCTURAL ASSESSMENT OF THE CONSOLIDATION JAIL PROJECT

1400 ST. ANTONIE
DETROIT, MICHIGAN 48226

NOVEMBER 16, 2016

PREPARED FOR:
WAYNE COUNTY BUILDING AUTHORITY
500 GRISWOLD
DETROIT, MICHIGAN 48226

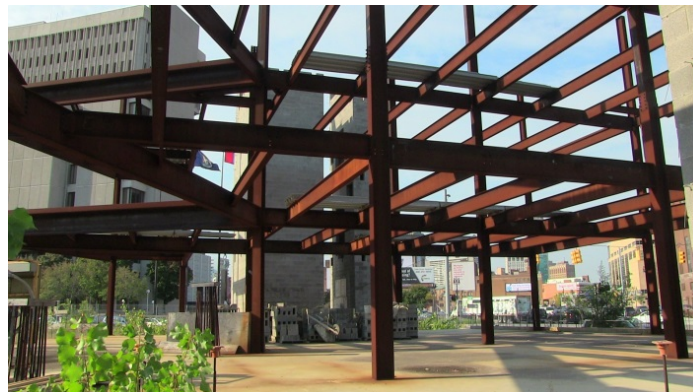
Our investigation of the structural steel followed AISC (American Institute of Steel Construction) 303-10 *Code of Standard Practice for Steel Buildings and Bridges* in procedure and inspection. MSG inspectors performed a visual inspection of the steel by scraping or brushing the layer of oxidation off and looking for any signs of damage or section loss. Area G contains a partially completed structural steel building exposed to the elements, as can be seen in *Figure 1*. MSG inspected every member for section loss and anything that would cause structural integrity, to which they found none.

Figure 1: Area G Structural Steel Building (Photo log Image #180)

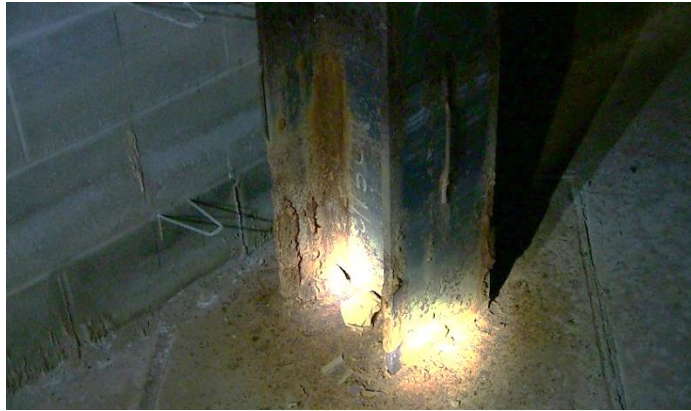
In the sub-basement, due to heavy rain fall and two of the permanent in-place sump pumps losing power there had been approximately 22 inches of water collected in the sub-basement at one point in time (depth measured from the water line marks left on the walls). All the water since has been removed after the sump pump intakes were cleaned and power restored. This rain water caused the oxidation at the base of the structural columns, as can be seen in *Figure 2*. After scraping and brushing the oxidation off, MSG inspected visually for any section loss or corrosion issues. There appeared to be no damage to the steel besides the oxidation that occurred on the surface.

Figure 2: Area G Basement Column Oxidation (Photo log Image #214)

MSG suggests the oxidation on structural steel members and cast-in-place (C.I.P.) steel plates where welding will take place to be sandblasted or removed by hand and power tools or by another method before continuing construction in accordance to ISO (International Organization of Standardization) 8501 *Preparation of Steel Substrates before Application of Paints and Related Products*. MSG is uncertain of the state of the structural steel after installation; if it will be painted or coated with fire protection, further cleaning maybe necessary. After the oxidation has been removed, MSG highly advises to further inspect the steel members for pitting or corrosion that would further compromise the strength of the steel.

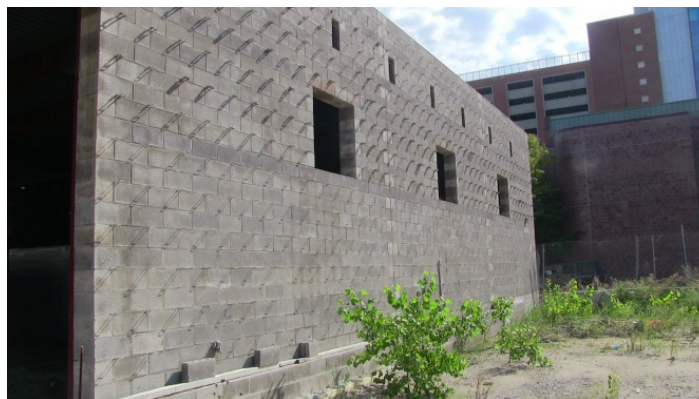
Figure 3: Area A Southwest Exterior Wall (Photo log Image #6)

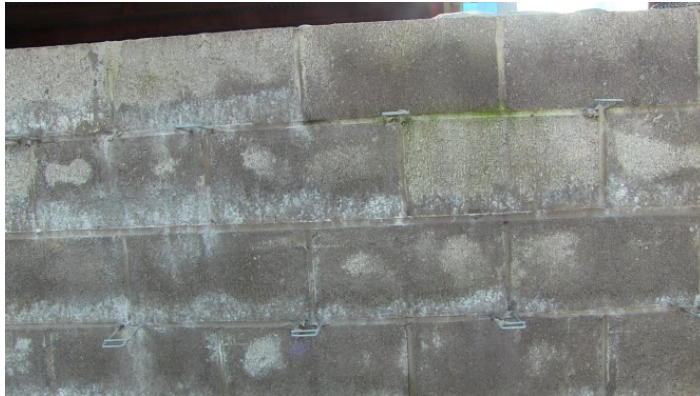
Inspectors looked for any cracks or bulges and checked for alignment and for any signs of movement. This assessment found no evidence of movement or structural integrity concerns with the masonry walls; however, there was some efflorescence present on the CMU walls, as seen in *Figure 4*. Efflorescence is due to excess moisture, and in this case from being exposed to the elements since construction on the site became idle. The efflorescence present does not appear to have caused any structural issues with the CMU

Figure 4: Area A Partial CMU wall (Photo log Image #5)

walls. MSG suggests the efflorescence be cleaned off the surfaces before continuing construction and to further prevent efflorescence from occurring in accordance with ASTM (American Society for Testing and Materials) C1400 *Standard Guide for Reduction of Efflorescence Potential in New Masonry Walls*.

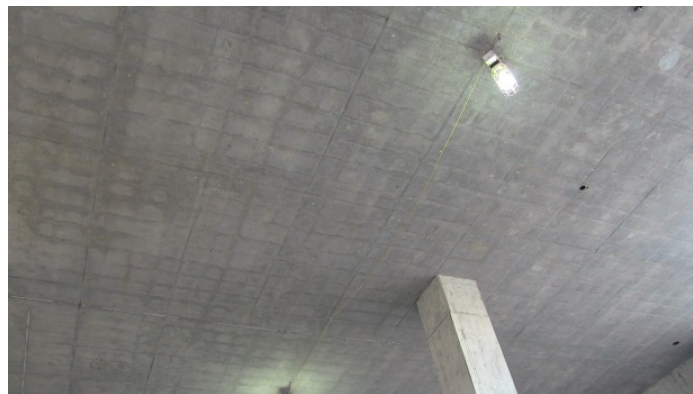
From the first floor looking at the bottom of the second floor slab a shadow effect can be seen of the layout of the rebar. This shows there is very little cover for the rebar. There is no discoloration in the concrete or rust bleeding present; therefore, this shadow effect is of no structural concern, just cosmetic. This shadow effect can be seen in *Figure 5* as the grid of the rebar can be seen ever so slightly. Review of the original construction plans and in reference to ACI 318-02/318R-02 (*Building Code Requirements for Structural Concrete*) for the concrete protection for reinforcement, the bottom reinforcement coverage in the second floor slab meets requirements and design.

Figure 5: Area F/F1, Re-steel Reflection (Photo log Image #175)

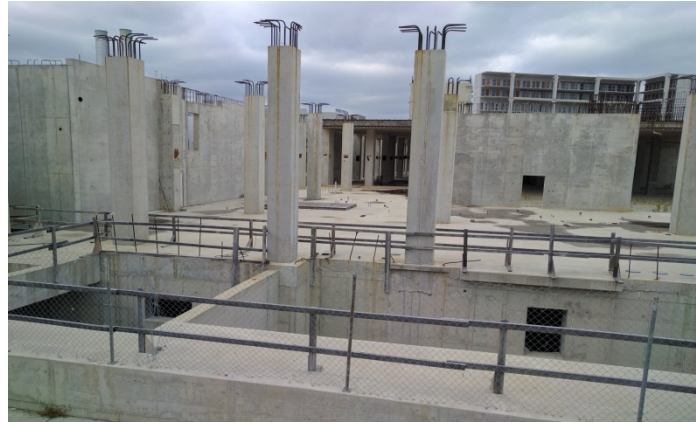
Hairline cracking can be seen throughout the concrete on-site; however, no major cracking due to deflection, flexural, or settlement. Hairline cracking is normal to a certain extent in concrete. The joints throughout the site appear to be excellent condition. There are some expansion cracks present in the C.I.P. concrete walls and slabs and in the CMU walls throughout the site, which is expected of any new construction. The cracking throughout the site is of no structural concern. Maps of the hairline cracks can be found in Appendix D. There was a large crack (dimensions of this crack have not been confirmed and possibly cannot be due to the location) that is of some concern in Area D on the Southern side of the area at a column aligned with one of the basement openings, as can be seen in the *Figure 6* and *Figure 7* below. We recommend repair of this crack in accordance with ACI 224.1R *Causes, Evaluation, and Repair of Cracks in Concrete Structures* prior to the upcoming 2016-2017 Winter Season.

Figure 6: South Open Area to Small Basement Chamber (Photo log Image #80)

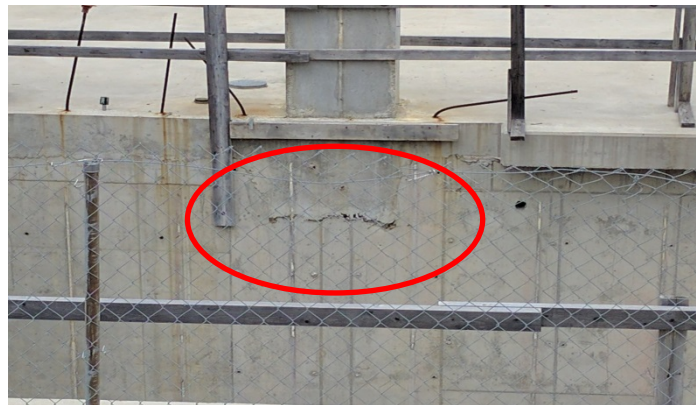
Figure 7: South Open Area to Small Basement Chamber, Crack Close-Up

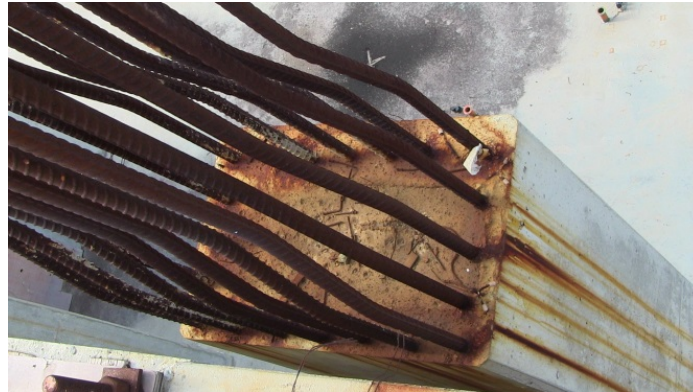
There is surface discoloration on the tops and running down the sides of the unfinished columns, due to the oxidation on the exposed rebar at the top and when it rained and snowed, the rust-colored water ran down the sides of the column and left the rust color on the columns. This is only visually on the surface and has

not compromised the strength of the concrete, as can be seen in *Figure 8*. The same has occurred where rebar is exposed at cold joints, as in *Figure 9* at a column base on the second floor slab.

Figure 8: Oxidation on Top of Unfinished Columns (Photo log Image #127)

In accordance with ACI 318-02, steel reinforcement with rust, mill scale, or a combination of both shall be considered satisfactory, providing the minimum dimensions and weight of a hand-wire-brushed test specimen comply with ASTM A615 *Specification for Deformed and Plain Billet-Steel Bars for Concrete Reinforcement*. "Tight" rust on reinforcing bars does not inhibit the bond between the reinforcement and the concrete; however, rust that flakes or can be brushed off is excessive and can inhibit the bond. MSG recommends the excessive rust on the steel reinforcement be sandblasted or removed by another method before continuing with concrete. The same should be done with any in place dowels and other embedment materials.

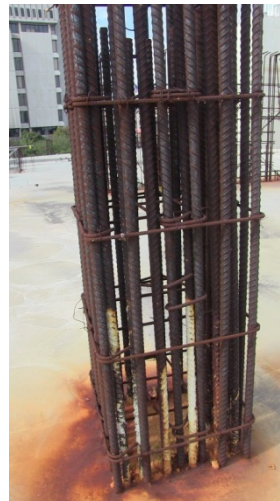
Figure 9: Oxidation at Base of Column on Second Floor Slab (Photo log Image #126)
